# Your survey and valuation report

██████████ Street, Shaw Heath,  
Stockport, ██████████

██████ February 2022

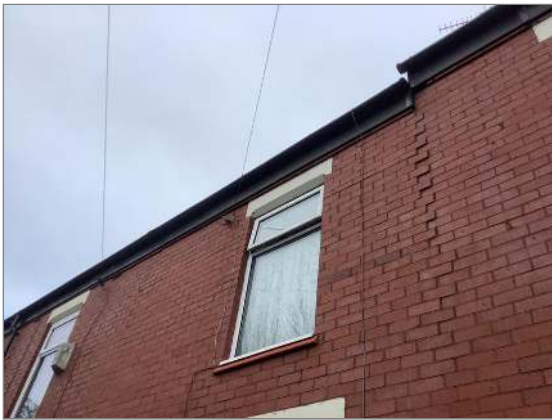
The rainwater goods appeared in fair condition for type and age with no significant defects of note.

*Photo - 18 Rainwater goods to the front*

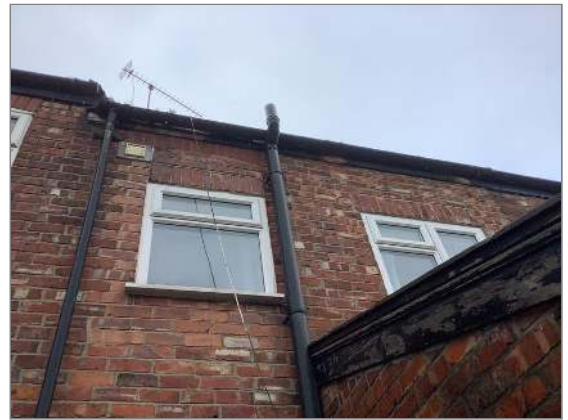
*Photo - 19 Rainwater goods to the rear*

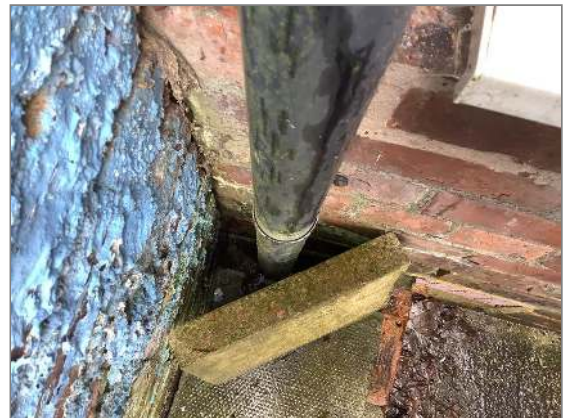
*Photo - 21 Downpipe to the rear*

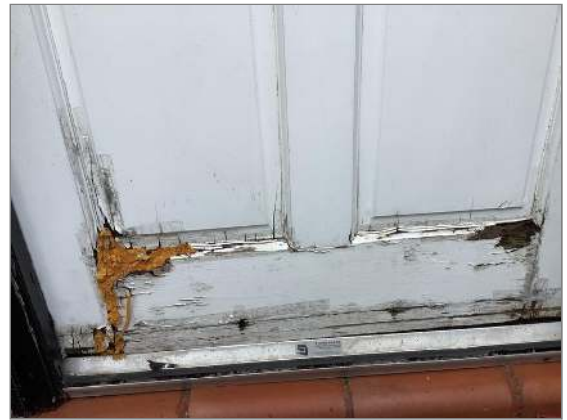
*Photo - 58 Defective and rotted timber door*

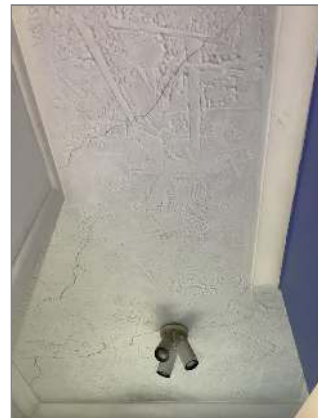
*Photo - 83 Cracks to textured coating ceiling to bathroom*

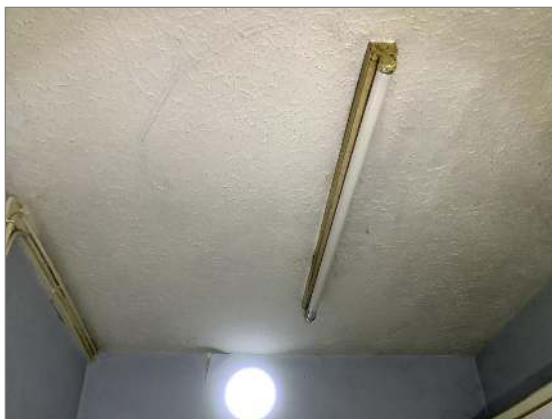
*Photo - 89 Rear lounge with hairline crack to textured coating*

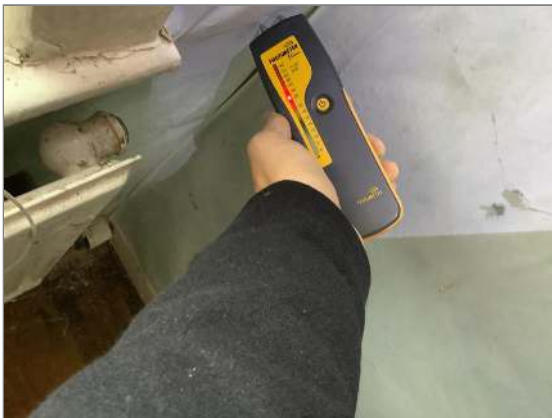
*Photo - 109 Likely defective plaster to the rear wall near party wall*

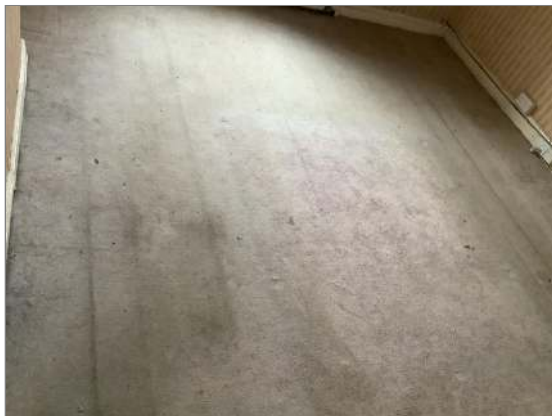
*Photo - 116 Carpet with creaking and bouncing floorboard to front bedroom*

As we have not been able to inspect the entire subfloor timbers, and given that damp was found to the ground floor walls, it is strongly recommended that further intrusive inspection is carried out of the subfloor timbers prior to commitment to purchase. If the ends of the joists bed into the walls and have not been wrapped in a protective membrane (which is unlikely, unless the floors have been relaid in more recent years) and the walls are damp, moisture can be transferred from the walls into the timbers which can lead to rot/decay.

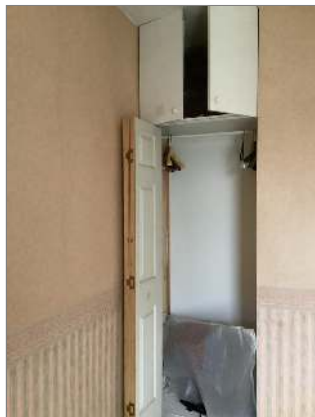
*Photo - 140 Stiff doors to the upper cabinet*

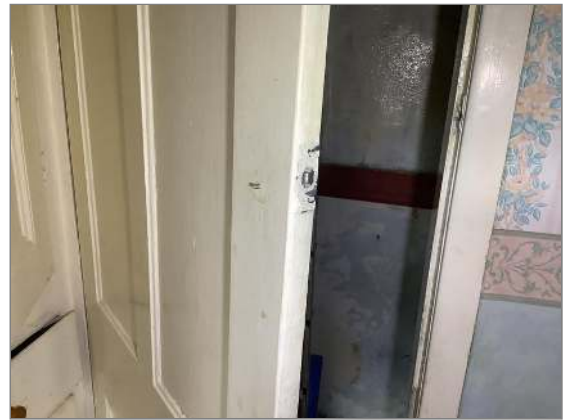
Photo - 155 Defective lock to the basement door
