# Your survey and valuation report

██████████ Street, Shaw Heath,  
Stockport, ██████████

██████ February 2022

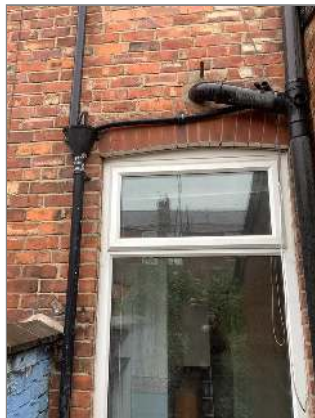
*Photo - 20 Downpipe to the rear*

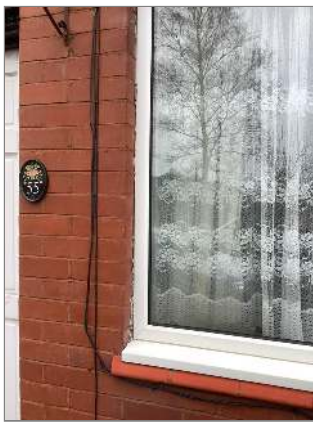
*Photo - 44 Gaps to sealant to the front lounge*

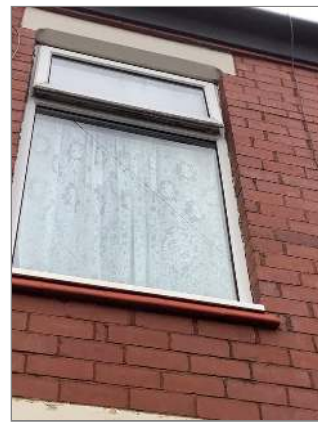
*Photo - 45 Gaps to sealant to the front bedroom*

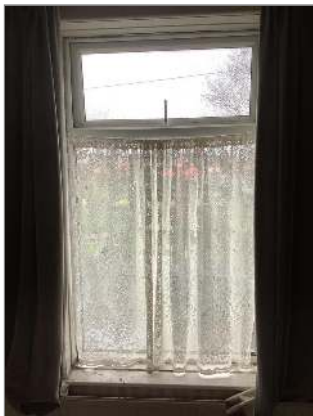
*Photo - 46 UPVC double glazed window without safety mark to low level glazing*

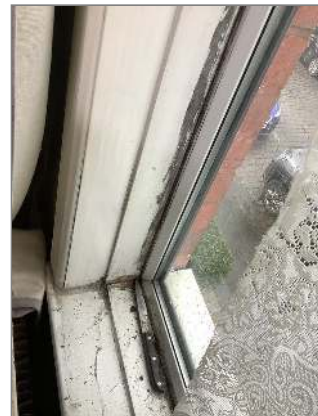
*Photo - 47 Gaps between front bedroom window frame and timber sub-frame*

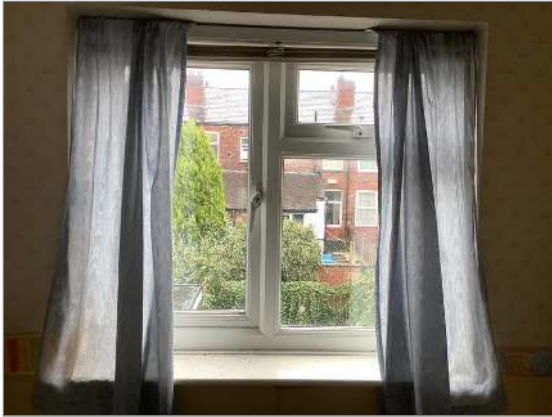
The rear bedroom window complies with escape window requirements however, the casement was locked and not tested. Further investigation on the functioning of the window is recommended.

*Photo - 48 Rear bedroom UPVC double glazed escape window*

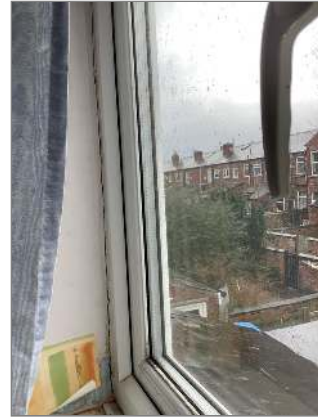
*Photo - 49 Gaps between rear bedroom window frame and the wall*

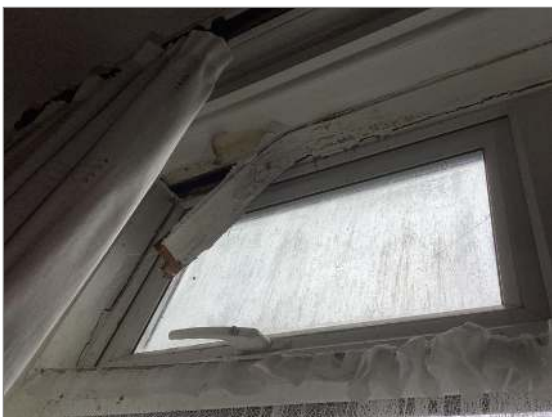
*Photo - 52 Detached and rotted timber frame to the front lounge window*

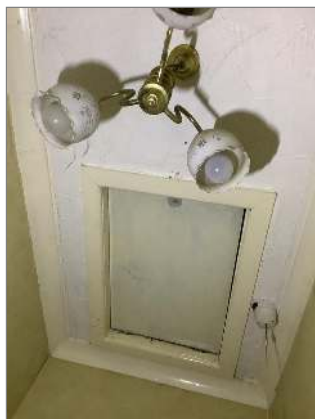
*Photo - 85 Textured coating to lowered landing ceiling*

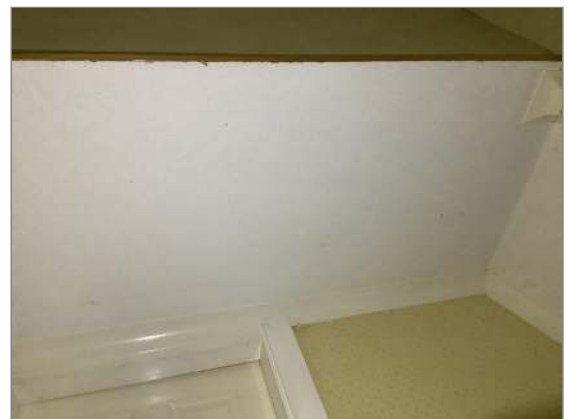
*Photo - 86*

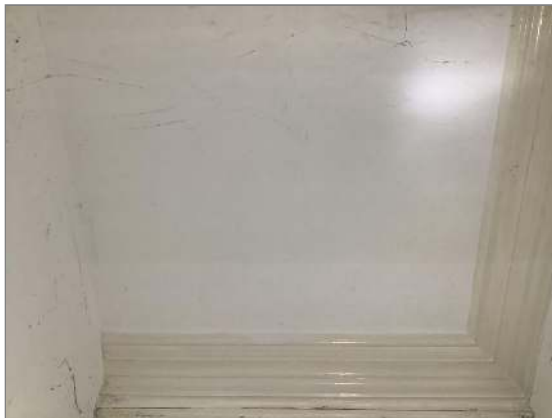
*Photo - 88 Wallpaper ceiling to vestibule and front lounge*

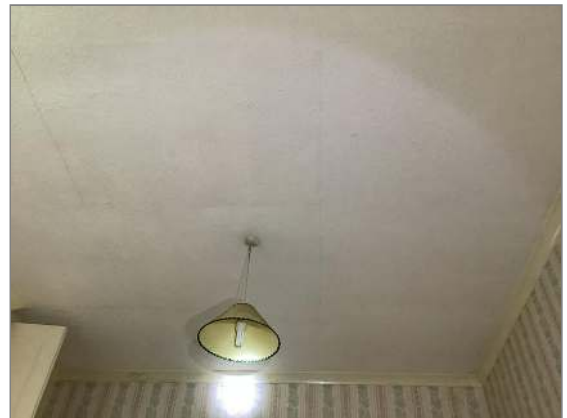
*Photo - 89 Rear lounge with hairline crack to textured coating*

Painted plaster finishes appeared in fair condition for their type and age however, plaster was likely defective to the area beneath the wallpaper finish to the rear lounge. Hairline cracking was found to the ground floor landing of the basement staircase. Repair of defective plaster, filling of hairline cracking and redecoration is recommended. Should cracking re-occur, it would be prudent to further investigate on any inadequate support to the affected areas.

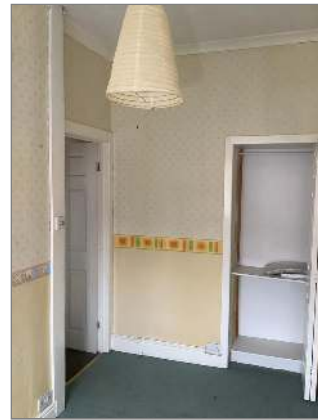
*Photo - 96 Wallpaper to stud wall and solid wall in the rear bedroom*

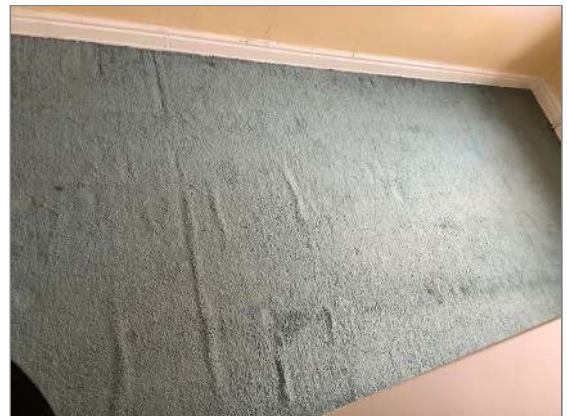
Suspended timber floors consist of timber floor boards being attached to floor joists. The timber floors were level within tolerance however, there was bounce flooring observed to isolated areas on the first floor. Repair of the bouncing suspended timber flooring is recommended. There were also creaking and vibration to the floor in general. This is common in properties of this age and not considered to be structurally significant.

*Photo - 117 Bouncing floorboard and aged carpet to rear bedroom*

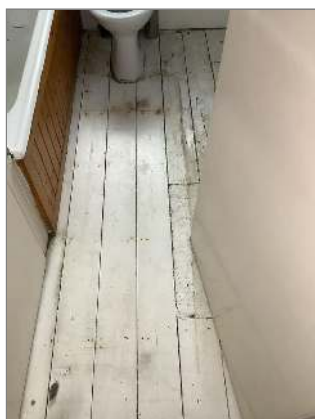
*Photo - 118 Timber floorboard bouncing near WC*

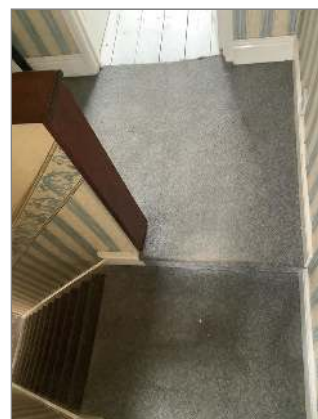
*Photo - 119 Bouncing and creaking landing*

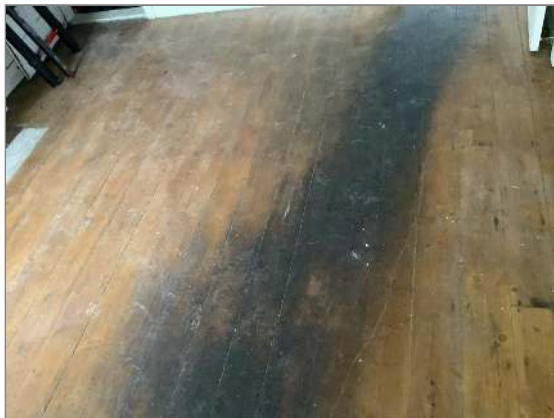
Photo - 122 Minor vibration to the timber floor board in rear lounge

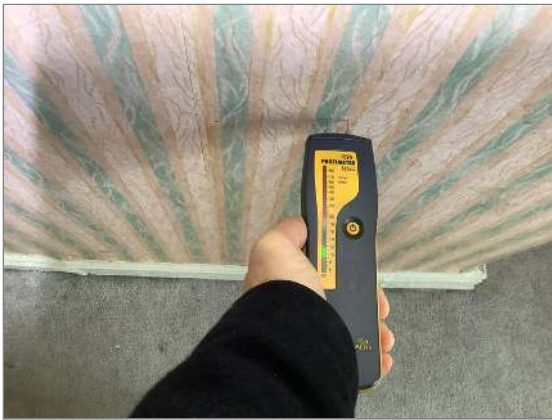
*Photo - 128 Front bedroom*

The chimney breasts were upright and no obvious defects were observed, except that the chimney breast of the front bedroom chimney breast was found leaning. Whilst there observed no sign of inadequate support, cracking and dampness to the concerned chimney breast, it is recommended to monitor if there is further leaning. Further investigation is recommended if further leaning of chimney breast is noted.

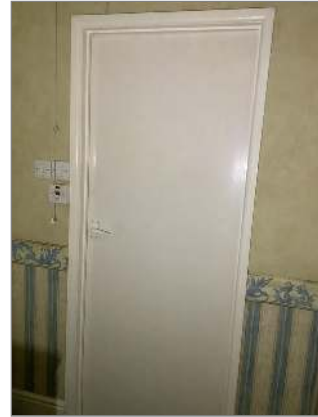
The door panels, door frames and architraves were of painted timber and in fair condition for type and age however, the bathroom door panel was found rub against the door frame. Creaking or stiff door panels and defective door latch were of note. Overhauling, easing and adjusting of door panels and replacement of defective door lock is recommended.

*Photo - 148 Creaking rear bedroom door*

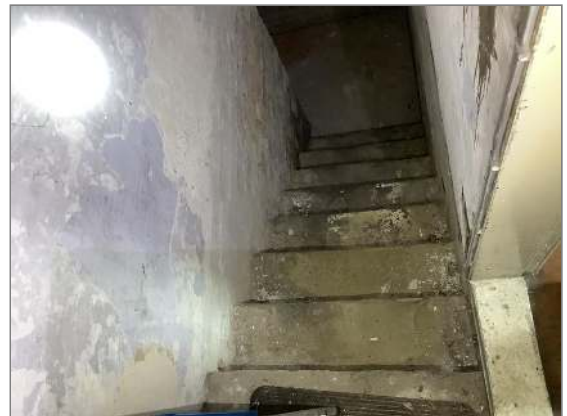
*Photo - 165 Solid staircase no handrail*
