# Your survey and valuation report

██████████ Street, Shaw Heath,  
Stockport, ██████████

██████ February 2022

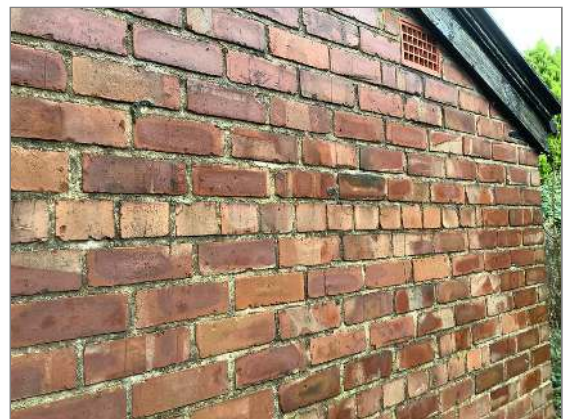
*Photo - 38 Kitchen solid wall 250 mm thk*

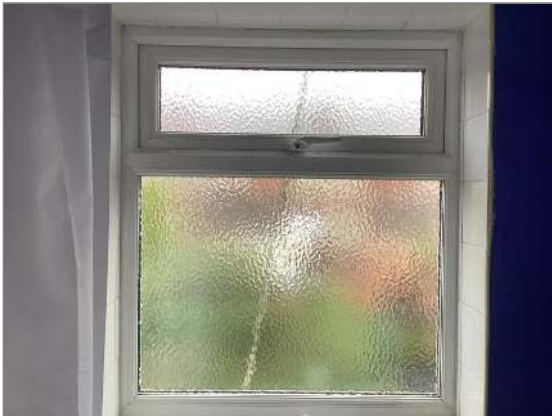
*Photo - 50 Bathroom UPVC double glazed window with stiff casement*

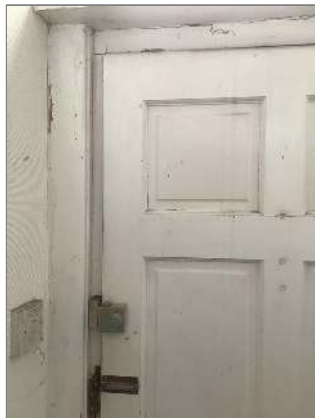
*Photo - 61 Timber stable door*

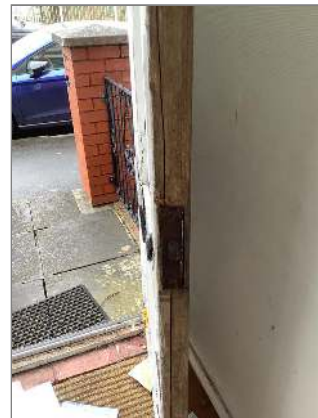
*Photo - 62 5 lever lock*

We recommend locks are changed when a property changes hands, as there is no way of knowing how many keys are in existence. Further advice should be sought from your insurance company to confirm that the present locking mechanisms will comply with their requirement.

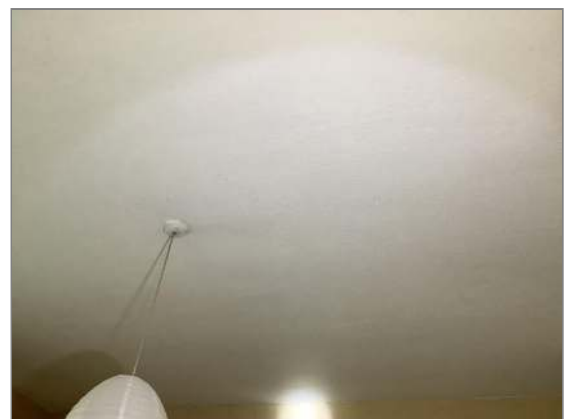
The ceilings were in fair condition with wrinkle wallpaper finishes. hairline cracking, defective lath and plaster finishes and flaked painting noted in isolated areas which is not structurally significant. Filling and redecoration is advised. Costs are not included.

*Photo - 80 Wrinkle wallpaper in front bedroom*

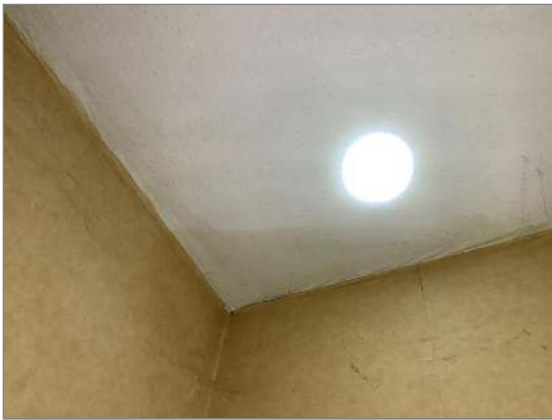
*Photo - 81 Wallpaper to rear bedroom*

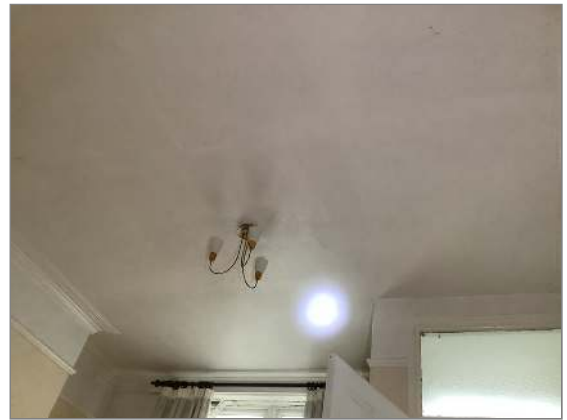
*Photo - 87 Front lounge with wallpaper to ceiling*

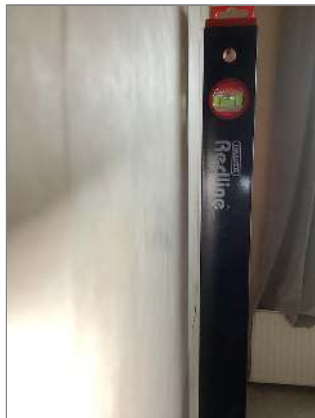
The chimney breasts were upright and no obvious defects were observed, except that the chimney breast of the front bedroom chimney breast was found leaning. Whilst there observed no sign of inadequate support, cracking and dampness to the concerned chimney breast, it is recommended to monitor if there is further leaning. Further investigation is recommended if further leaning of chimney breast is noted.

*Photo - 129 Front bedroom*

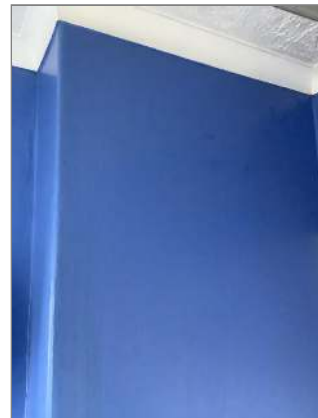
*Photo - 130 +/-12mm for 900 mm length*

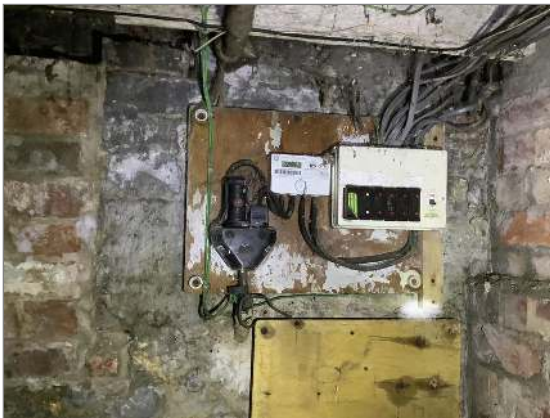
Photo - 175

There was no current electrical certification confirming the condition of the electrics within the property.

In the absence of a current test certificate, we must designate a level three risk. If certification is available, please ask your legal advisor to check the validity of this evidence. Electrical installations to be checked and certified by an NICEIC qualified engineer prior to purchase, unless evidence of recent testing is provided and verified.

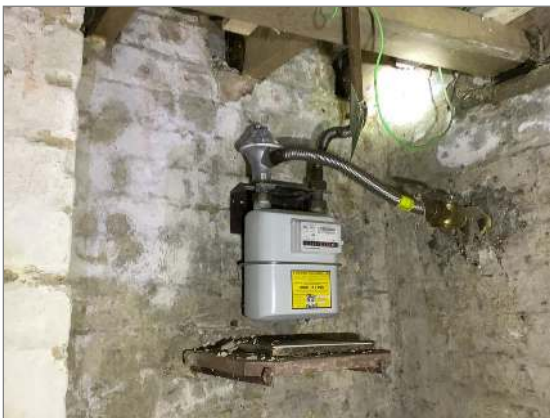
Photo - 176

The gas meter is located internally in the basement. It visually appeared in satisfactory condition.

No evidence of recent testing was observed.

In the absence of a current test certificate, we must designate a level three risk. If certification is available, please ask your legal advisor to check the validity of this evidence. All gas installations to be checked and certified by a Gas Safe engineer prior to purchase, unless evidence of recent testing is provided and verified.

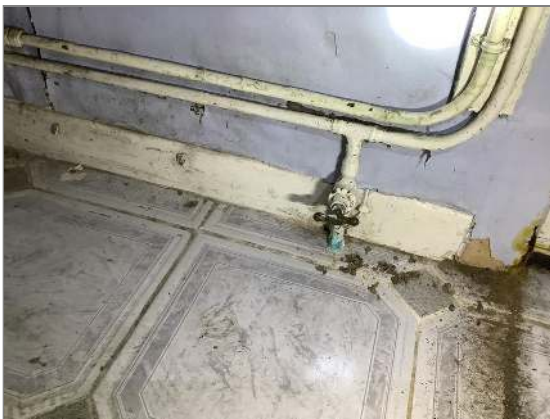
Photo - 177

The stopcock serving the property is located in the kitchen. Every property with a mains water supply requires both internal and external stopcocks for proper control of the incoming water supply. It is important to know the position of the stopcocks so that the water can be turned off in an emergency and when carrying out alterations/repairs to the plumbing system. They should be checked regularly to ensure that they open and close properly. Stopcocks can become stiff and difficult to operate. It would be prudent therefore to periodically open and close the valves to ensure their effectiveness in an emergency.

The age of the property suggests that the supply pipe to the water may be of lead and if this is the case then it should be replaced with modern copper or plastic piping. Further enquiries should be made via the relevant utility company. Before 1970 many water supply pipes were made of lead and research has shown that small quantities can pass into the water. In some cases, lead can accumulate in the body and become a health hazard. This can be a particular problem in areas that have soft water. Lead pipes are also vulnerable to leakage.

The water system should be checked by a specialist prior to exchange of contracts to ensure there are no leaks.

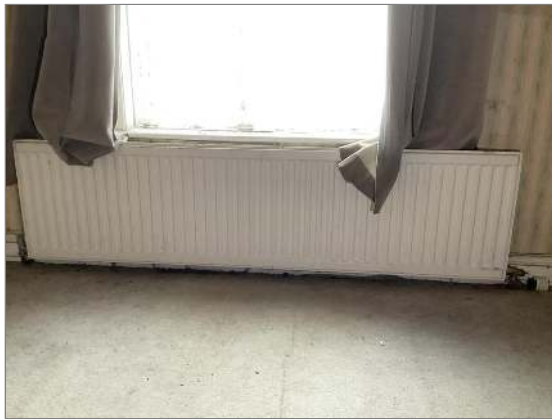
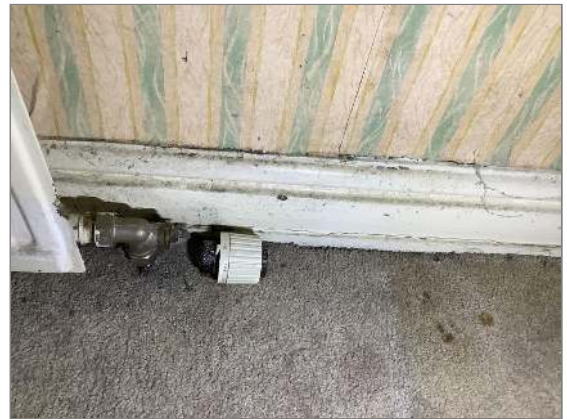
Pressed steel radiators appeared in aged condition with defective radiator noted to the front bedroom.

A level three risk is stated as defective radiator and absence of testing certificate was noted.

All heating installations to be checked and certified by a Gas Safe engineer.

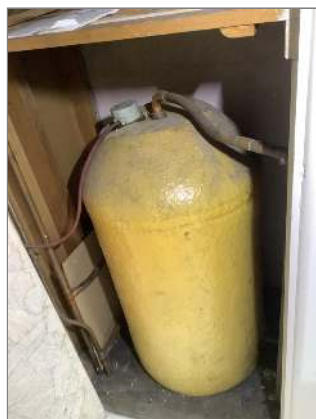
Photo - 180 Bathroom

The electric hot water cylinder should be maintained on a cyclical basis to enhance proper functioning. No test was conducted to the electric hot water cylinder.

In the absence of a current test certificate, we must designate a level three risk. If certification is available, please ask your legal advisor to check the validity of this evidence. Hot water installation to be checked and certified by a competent engineer prior to purchase, unless evidence of recent testing can be provided.

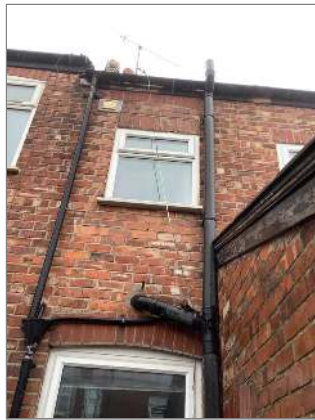
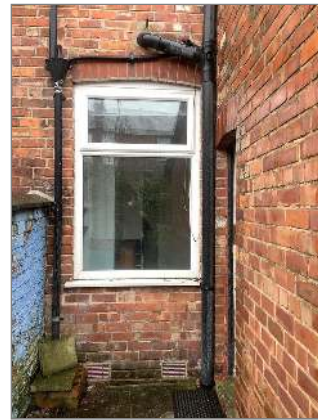
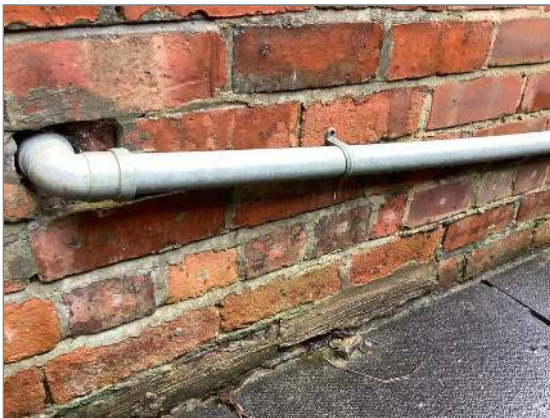
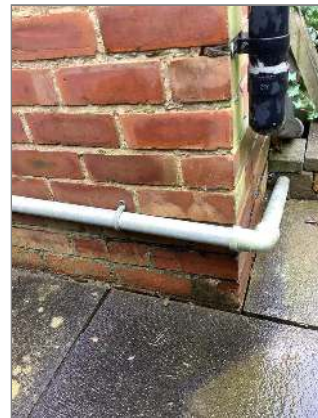
UPVC soil pipes, and UPVC waste pipes to the property were observed.

Drainage appeared in satisfactory with no evidence of leaks.

We recommend instructing a CCTV drainage survey to ascertain the condition of the underground drainage system and any likely repairs or impacts to the property.

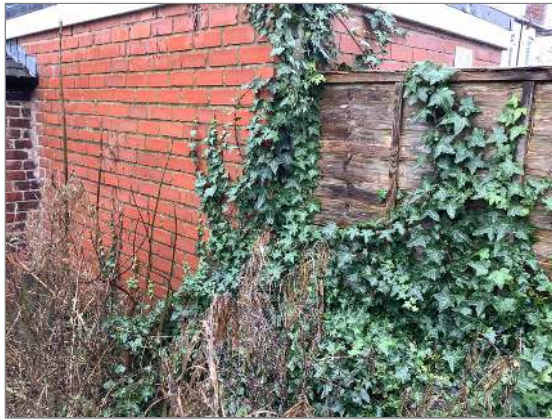
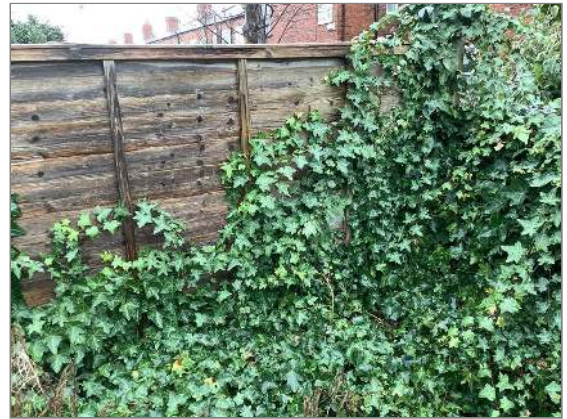
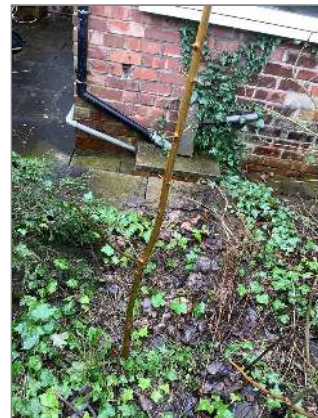
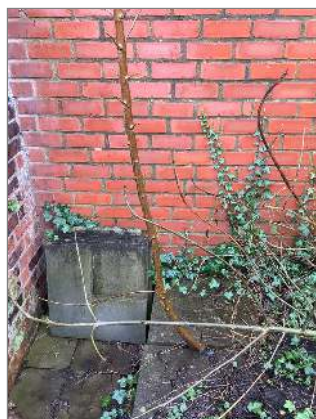
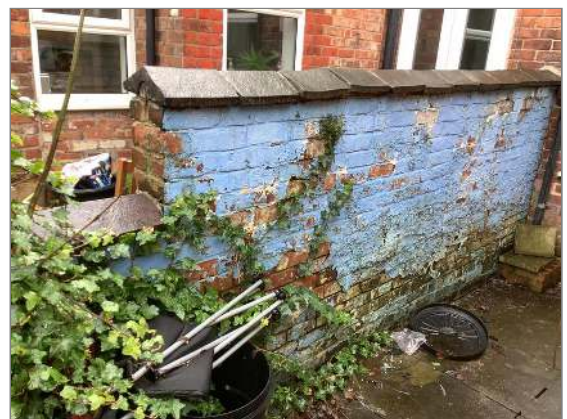
Ground coverings appeared in poor condition with weeds covering most of the rear ground and part of the front ground. Weeds should be removed in due course. Ground coverings should be maintained in the normal way.

Japanese knotweed is believed to be growing in the rear ground. Further investigations are recommended immediately. Japanese Knotweed is a non-native, highly invasive plant, that can damage footpaths, driveways, patios and in the worse cases, the property itself. It is very difficult to get rid of and remedial works are usually expensive, onerous, and can take a number of years to complete. Japanese Knotweed can affect future saleability, mortgage-ability, and value of the property. You should ask an appropriately qualified person to inspect prior to purchase.

Timber fencing appeared in aged condition with vegetation and weeds covering in general. It is recommended to remove vegetation from the timber fencing and replace defective timber fencing.

Defective paint finish and pointing to the brick wall to the side boundary of the rear garden was noted. Removal of painting and patch repair of pointing is recommended.

The metal vehicular gate was in aged condition and could not be closed. Repair of the metal vehicular gate would be desirable.
